Report No.: SL92219290811901FW  
**TEST REPORT**  
26-07-2022

**Sampling Country:** SGS China SL  
**ZDHC Sampler's Certification No.:** 8F146506808  
8F146508678  
**Sampling Date:** 12-07-2022  
**Sample Received Date:** 12-07-2022  
**Test Performing Period:** 12-07-2022~ 26-07-2022  
**No. of Samples:** Water (2)  
**Sample Descriptions:** 1) Incoming water (Grab)  
2) Raw Wastewater(Discharged Wastewater) (6-hour Composite)  
**Sample Volume** 1) Incoming water 8L  
2) Raw Wastewater(Discharged Wastewater) 20L  
**Testing Institute:** SGS China GZ Lab  
**Discharge Method:** Indirect Discharge

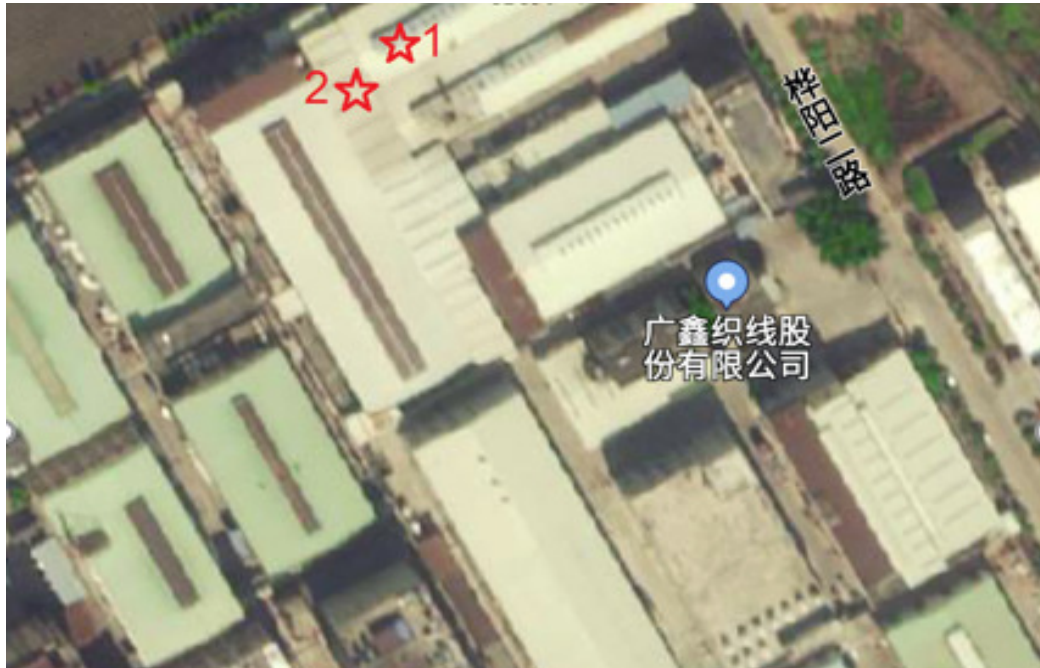
1. Incoming Water
2. Raw Waste Water(Discharged Waste Water)

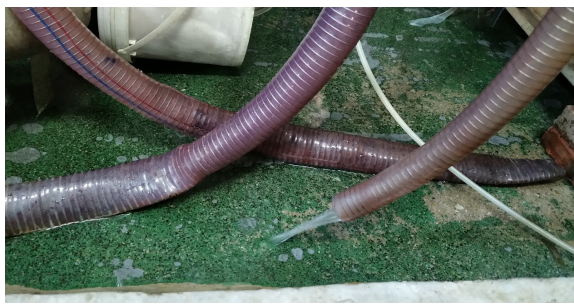
#### SAMPLING LOCATION, CLOSE-UP VIEW

GPS Data: 23°10'24.67" N, 113°59'22.75" E

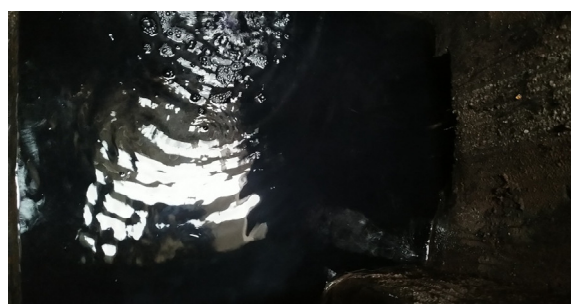
#### SAMPLING LOCATION, CLOSE-UP VIEW

### Raw Waste Water (Discharged Waste Water)

GPS Data: 23°10'24.00" N, 113°59'22.35" E

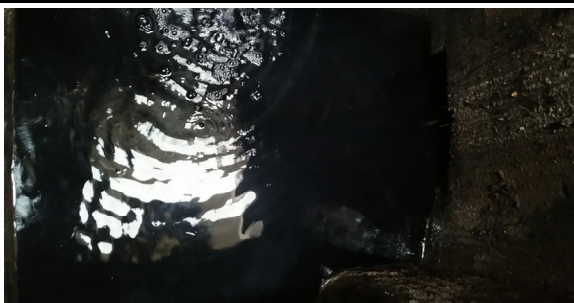
### PERSISTENT FOAM

| | Sample ID | | 92219290811901-1 | 92219290811901-2 | Factory Performances | | | Local Wastewater Discharge Requirement** |
|---|---|---|---|---|---|---|---|---|
| Persistent Foam | - | Not Visible | - | - | Not Visible | - | N/A | N/A |

Date & Time of Measurement: 12-07-2022 ; 11:40

Sampling Location: Wastewater discharged outlet
